Ball Grid Array (BGA) Voiding Affecting Functionality

A customer contacted ACI Technologies regarding a high failure rate of their assemblies. They provided assemblies to be X-rayed and inspected for the purpose of identifying any process related issues such as (but not limited to) solder and assembly workmanship and evidence of damage due to moisture related problems during reflow (a.k.a. “popcorning”).

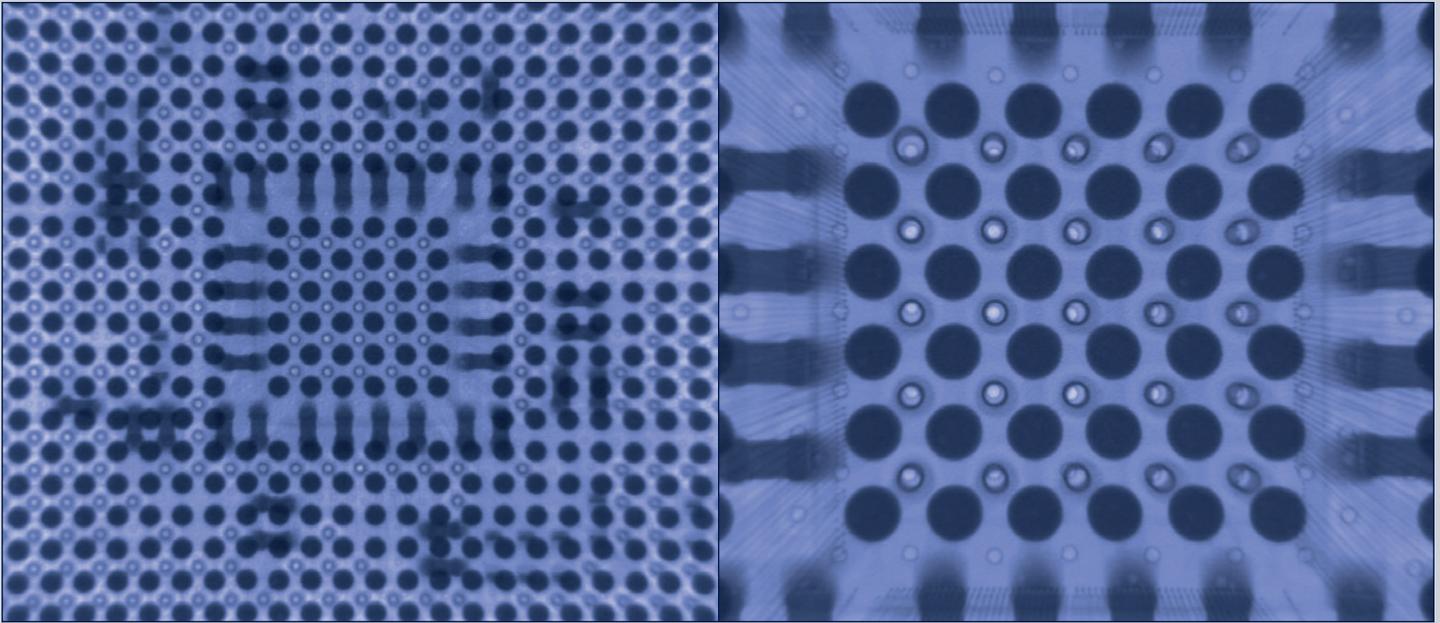
No issues were observed with the large BGA components on the assemblies. Representative via X-ray inspection images (Figure 2) show that the die, wire bonds, and solder balls appeared well-formed and provided no indication as to a loss of functionality.

Figure 2: X-ray images of a large BGA component; left is whole component with minimal voiding, right is a view of the die with wire bonds intact and with minimal voiding of the solder balls.

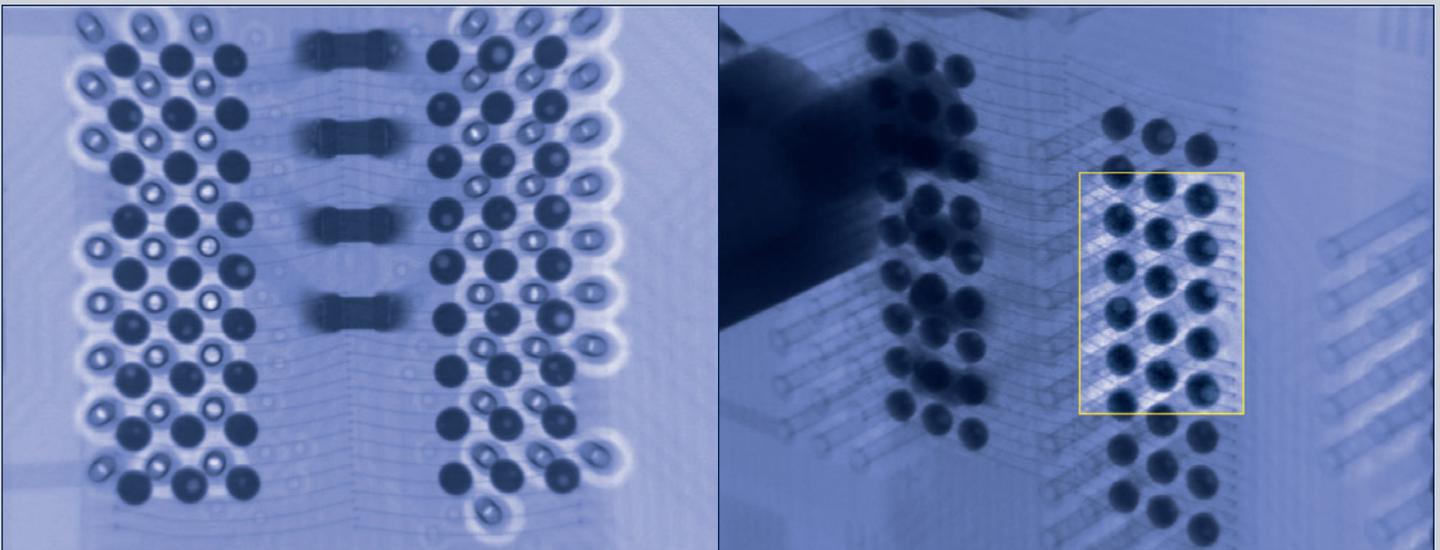
For the smaller BGA style components, assembly and solder workmanship issues were identified as shown in Figure 3. Specifically, the elevated level of voiding in the solder joints on the 54-pin memory components was identified as a potential contributor to failures. IPC A-610 specifies voiding that exceeds 25% of the X-ray image area is a defect for all classes of production. ACI recommended that any voiding that exceeded 10% of the ball X-ray image area be treated as a process related process indicator condition (i.e. a condition that indicates excessive variation from the intended result). Although detailed voiding analysis was not performed on these samples, it was apparent from visual inspection that there were many solder joints on these parts that exceeded the 10% recommended limit. Many of the

voids appeared to be at an interface which may have contributed to signal issues. The sizes of the voids also may have interfered with long term reliability.

In addition, the location of voids in a BGA solder joint can be critical, regardless of the void size. Voids that occur at the solder joint/printed circuit board (PCB) land interface (“interface voids”) can impact the reliability of the resulting solder joints. This occurs because the yield strength of a solder joint is related to the surface area of contact between the solder and the surfaces it joins. Interface voids reduce this contact area and can lead to mechanical failure of the solder joint. Some solder joints, such as those viewed in Figure 3, appeared to have voids that occurred at the interface and have reduced the wetting contact areas on the PCB.

Voiding can be a result of a variety of causes which include the properties of the flux used on the assembly and the profile used to reflow the solder paste. Interface voids can also be a result of a non-wetting or dewetting condition on the PCB land.

Figure 3: X-ray images of BGA voids in the smaller memory chip component; left is a view from above with significant voiding of the solder balls, right is an oblique angle view showing the voiding along the edges of the solder balls. Note the high contrast region (outlined in yellow) showing the difference between the dark and the lighter void areas.

ACI recommended that the customer further investigate the voiding observed on the 54-pin memory components. Two areas of attention were recommended: (1) the process used to assemble and solder the memory components and (2) the interface voids that were observed.

The interface voids should be investigated to determine if their location is actually on the interface. Cross-sectional analysis could be used to specifically examine a solder joint of interest and accurately determine the location of the void. This analysis would include evaluation of the PCB land for evidence of any contamination or metallurgical issues that would result in improper solder wetting.

The voiding level observed on the 54-pin memory should be reduced by adjusting the assembly process. One method is to test alternative solder pastes that may result in lower amounts of voiding in the resulting solder joints. Another method is to adjust the solder reflow profile to reduce the voiding present in the solder joints. Both methods can be used together or modifications to the reflow profile can be performed using the existing production solder paste.

ACI recommended cross-sectional analysis of the samples and X-ray analysis of future samples produced on a modified reflow process.
